Mooring Tail Guidelines

This guideline is intended for use as part of Line Management Plan (LMP) according to OCIMF MEG4 in conjunction with Installation guideline and Rope use and care manual.

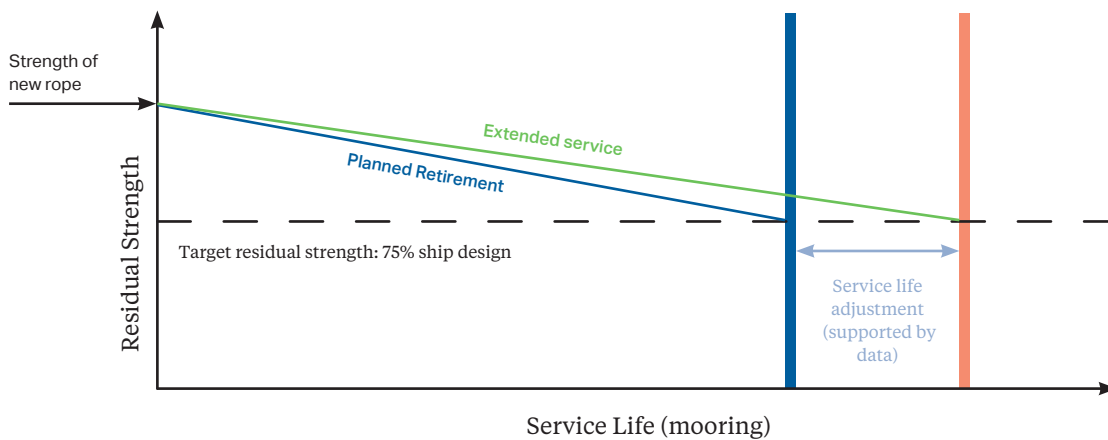
Fitting		& Ship Design MBL		OCIMF (2018). Mooring equipment	
		Max LDBF		105	LDBF = 100-105% ship design MBL		
Increased loading on line leading to increased rate of damage and risk of loads exceeding residual strength	Mooring Line		Ship design MBL		100		Ship design MBL
					75		Residual Strength – Recommended retirement of mooring lines as according to OCIMF MEG4
Working loads are within maximum expected values for anticipated environmental conditions	Mooring Line		WLL (50-55%)		55 Wire		Working Load limit
					50 Synthetics	Working Load limit	
Typical operational range	Fitting				22	Recommended working load	
					0

Service life adjustment according to OCIMF MEG4

OCIMF MEG4 recommends retiring mooring lines when the residual strength has reached 75% of the Ship Design MBL. Today this can only be determined by a destructive test.

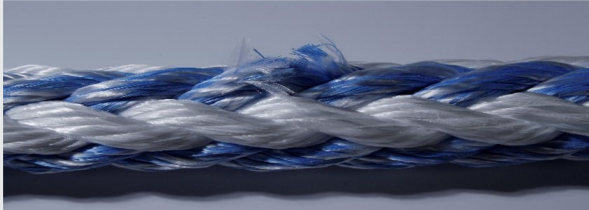
Visible cut in fibers. Visible cuts in very few yarns is acceptable, however monitoring the rope is recommended. Inspect and find sharp edge in the path of the rope causing the cut and repair. Protect the rope.

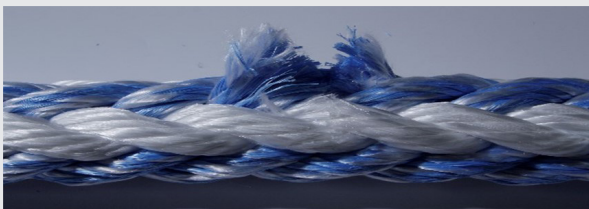
Cut yarns clearly visible on several yarns in the rope. Rope must be retired. Inspect and find sharp edge in the path of the rope causing the cut and repair the area. Protect the new rope.

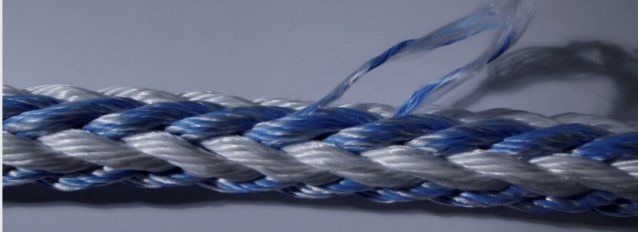
Pulled yarns can be repaired by working the yarns into the rope or cutting off close to the rope surface. Inspect and find the obstacle causing the pulled yarns and remove or repair.

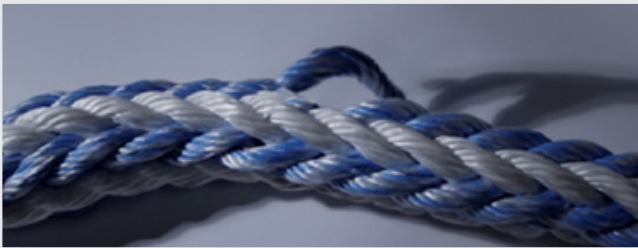
Pulled strand can be repaired by working the strand into the rope by locating the damage on the length of the rope and by pulling and settling the strand. Inspect and find the obstacle causing the pulled strand and remove or repair.

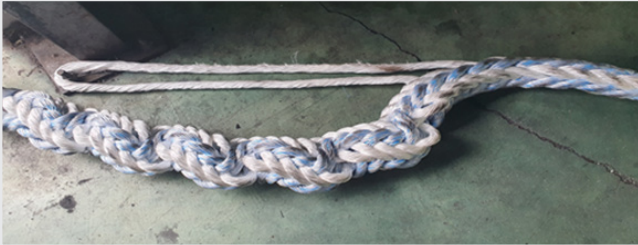
Pulled strand caused major constructional damage on rope's length. Ropes must be retired. Inspect and find the obstacle causing the pulled strand and remove or repair.

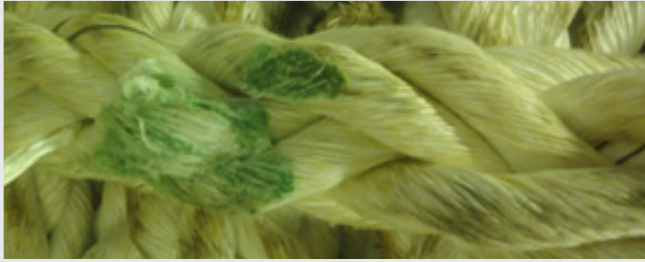
Rope log shows that there has been significant exposure to chemicals. Rope must be retired.

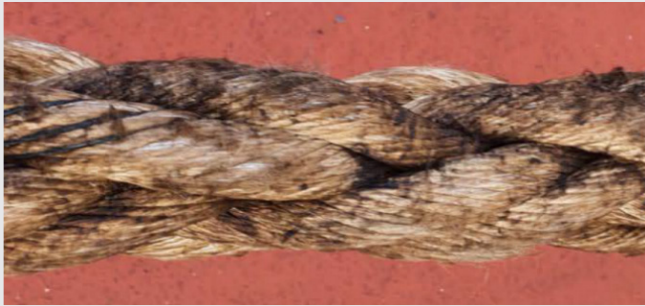
Rope discoloration, brittle fibers, fusion, bonding of fibers, hardness. Chemical exposure suspected. Rope must be retired.

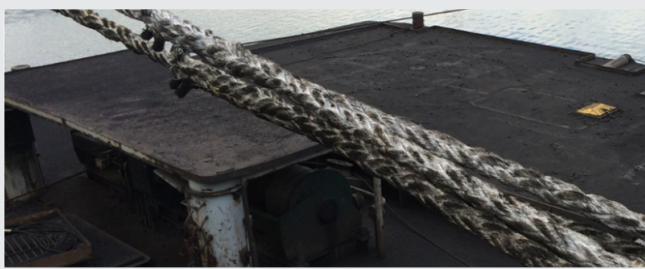
<p>Rope and deck/floor dirty. Recommended to inspect regularly for internal and external abrasion.</p>
