Mooring Ropes Inspection and Retirement Guidelines – Timm Acera daGama

1. Introduction

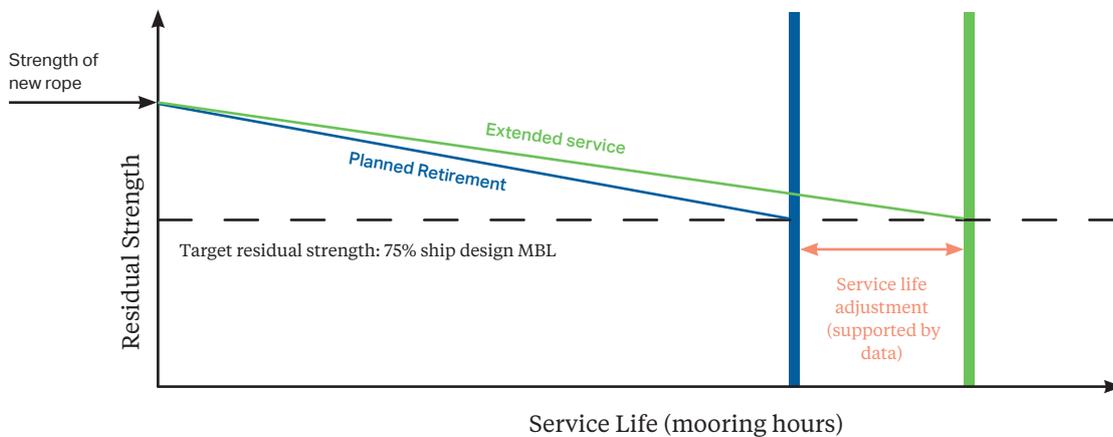
Service life adjustment according to OCIMF MEG4

OCIMF MEG4 recommends retiring mooring lines when the residual strength has reached 75% of the Ship Design MBL. Today this can only be determined by a destructive test.

For more individual retirement criteria we recommend performing a test of residual strength as mentioned by OCIMF MEG4. By performing a test and gradually building up historical data on different ropes and tails, the vessel will create the optimal solution. In addition to that, regular inspection with certain intervals should be performed and ropes and tails discarded if deemed necessary.

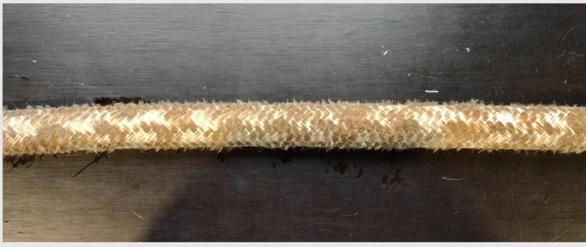
Cover is intact, no visible damages.

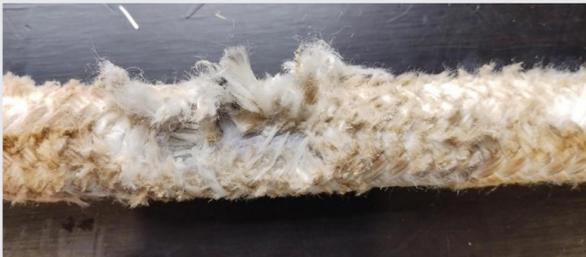
Visible damages to the cover, but the core is still intact without damages. Recommend using Timm Repair Kit to fix damages as soon as possible to prevent further damages to cover and core.

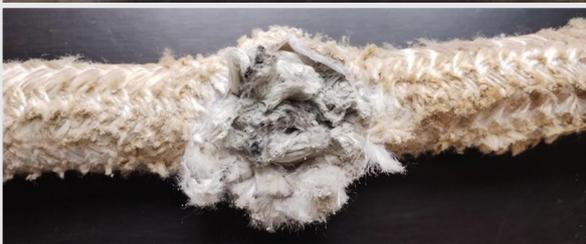
Visible damages to the cover and the core. Rope must be retired

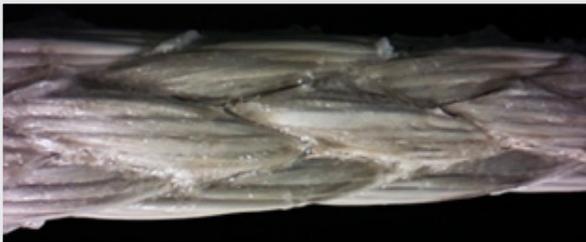
Fibers intact, no visible external damage.

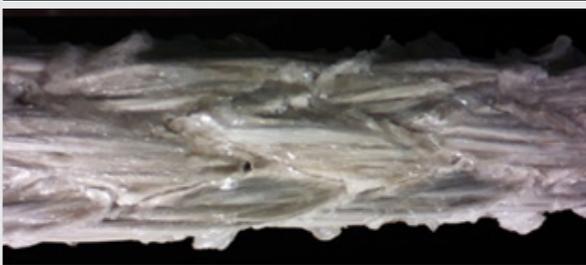
Visible abrasion localized where rope has been in contact with uneven surface. Recommend monitoring the rope, inspect and if needed repair the hardware and protect the rope.

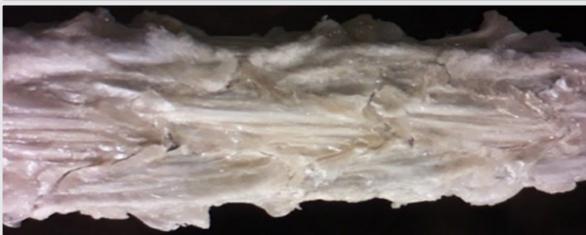
Abrasion clearly visible on more than 10% of the cross section of the rope. Rope must be retired.

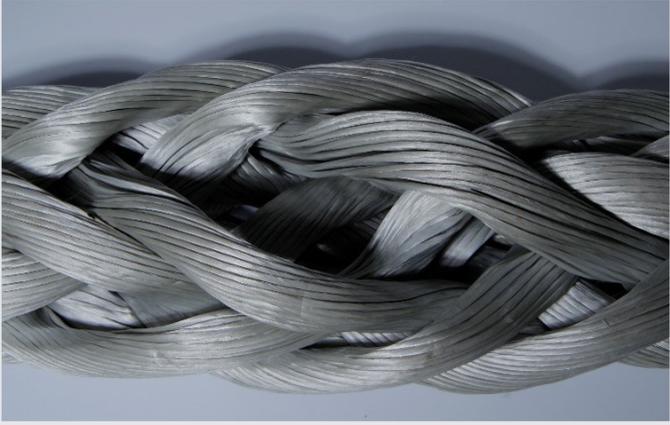
Green	Fibers intact, no visible external damage.

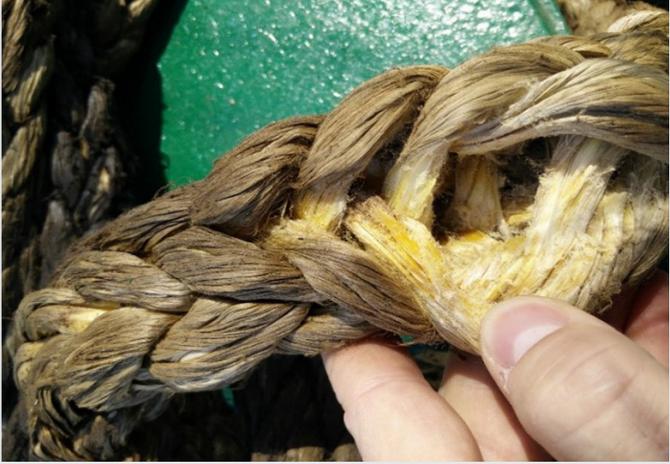
Yellow	Minor visible internal abrasion. Some broken filaments. Recommend monitoring and inspecting the rope.

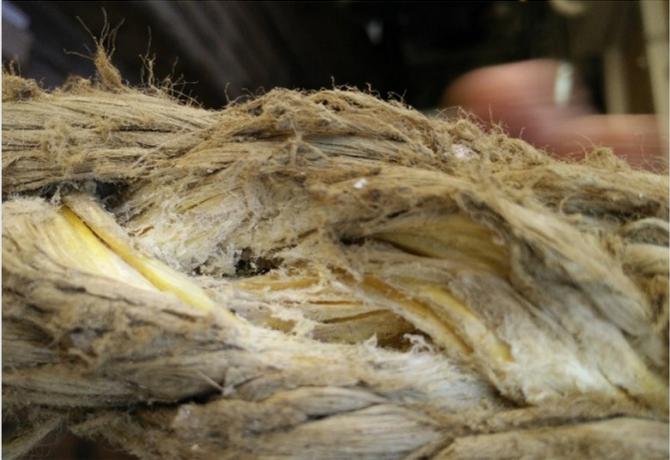
Red	Internal abrasion clearly visible. Broken and powdered filaments in the center of the rope. Rope must be retired.

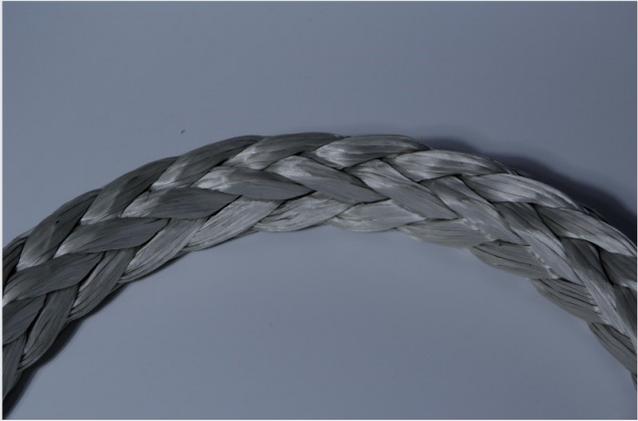
<p>Fibers intact, no visible external damage.</p>

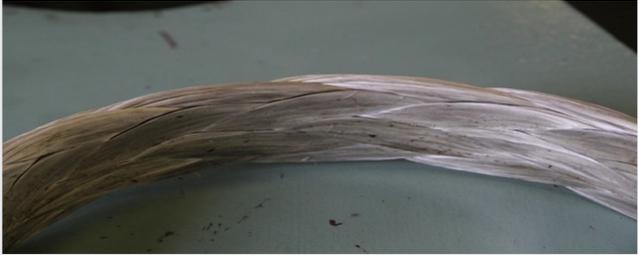
<p>Glazed appearance, it is possible to recover the original shape of the rope by flexible bending and further use under tension. Monitor and inspect the rope regularly, investigate the root cause and do corrective actions. Recommend protecting the rope.</p>

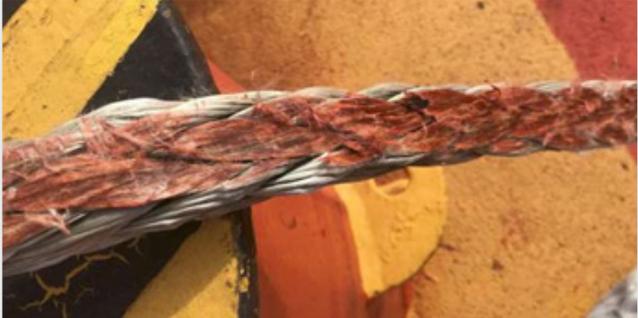
<p>Glazed appearance due to heat build-up and melted fibers. Fibers damaged and non-recoverable flattening. Rope must be retired.</p>

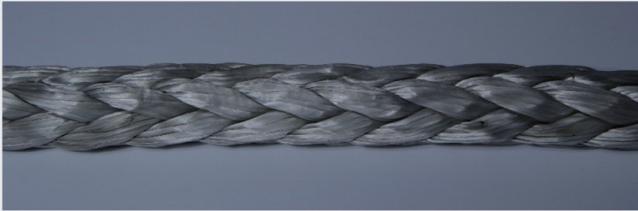
Fibers intact, no visible cuts.

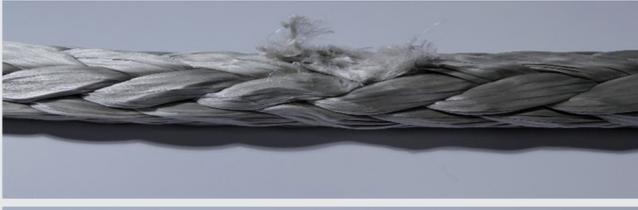
Visible cut in fibers. Less than 3% of total amount of yarns. Recommend monitoring the rope, inspect and find sharp edge in the path of the rope causing the cut and repair. Protect the rope.

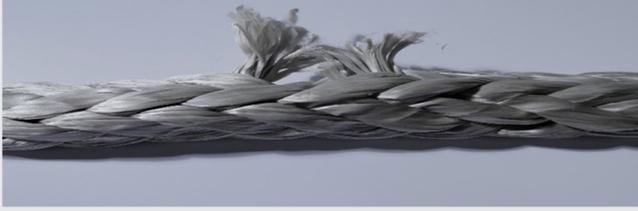
Cut yarns clearly visible on more than 3% of total amount of yarns in whole rope. Rope must be retired. Inspect and find sharp edge in the path of the rope causing the cut and repair. Protect the new rope.

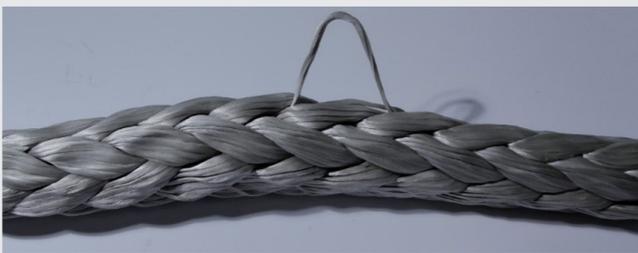
Minor damage. Hide the fibers inside the rope. Inspect and find the obstacle causing the pulled yarns and remove or repair.

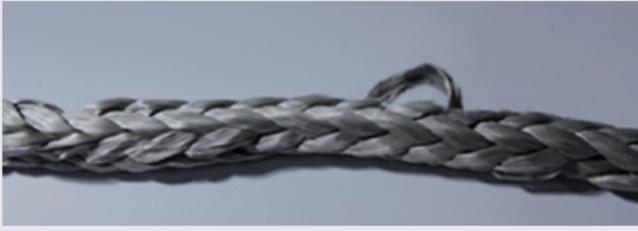
Pulled strand can be repaired by working the strand into the rope by locating the damage on the length of the rope and by pulling and settling the strand. Inspect and find the obstacle causing the pulled strand and remove or repair.

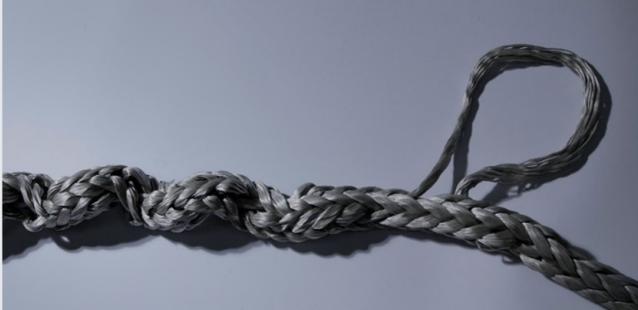
Pulled strand caused major constructional damage on rope's length. Ropes must be retired. Inspect and find the obstacle causing the pulled strand and remove or repair.

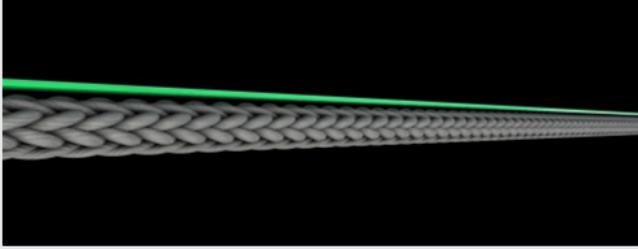
No twist. Perfect conditions.

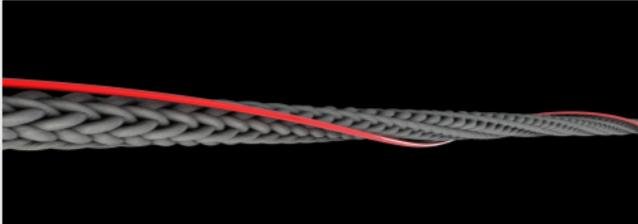
Visible twist. Risk of decreasing the rope's strength. Untwist the rope in opposite direction at first possible occasion.

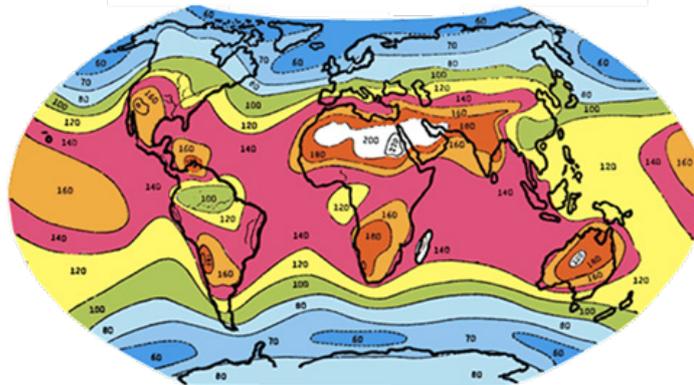
Generalized Isolines of Global Radiation (Kcal/cm²/year) expressed in Kilo-Langley per year) By H.E. Landsberg

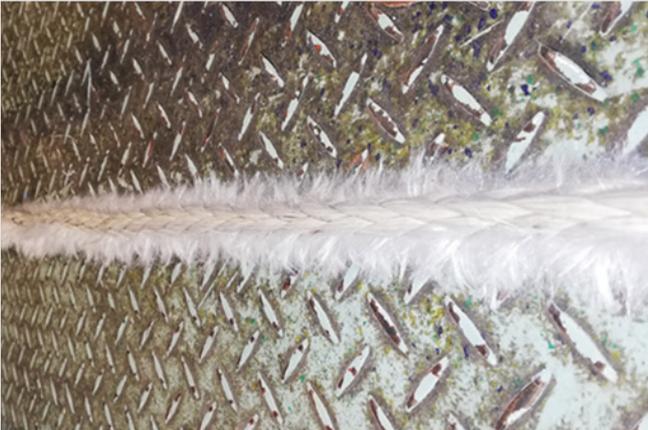
UV degradation on rope after tension is applied. Damaged fibers easily visible. The signs of UV degradation are not always visible before tension is applied. Attention must be paid to ropes that have been exposed to sunlight over an extensive period of time. Rope must be retired.

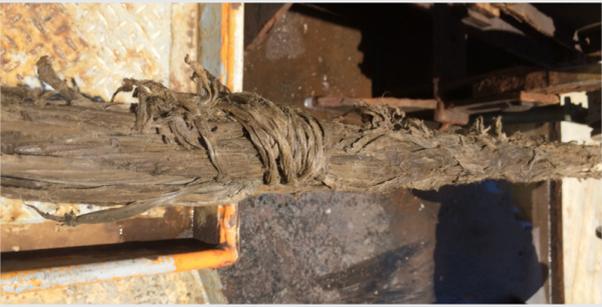
<p>Rope log shows that there has been significant exposure to chemicals. Rope must be retired.</p>

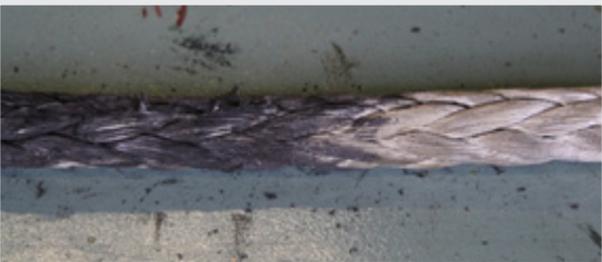
<p>Rope discoloration, brittle fibers, fusion, bonding of fibers, hardness. Chemical exposure suspected. Rope must be retired.</p>

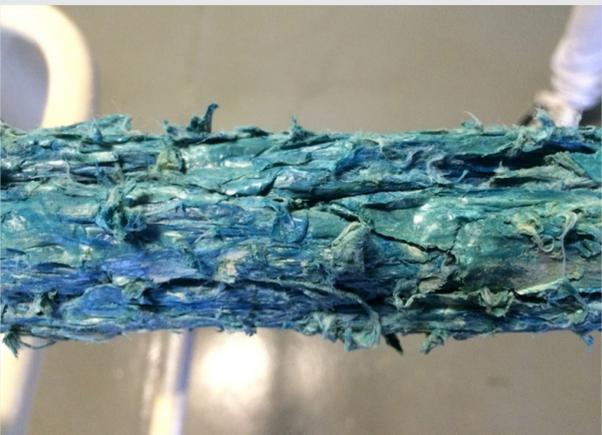
<p>Known significant exposure to high temperature. Melted and/or discoloration.</p>

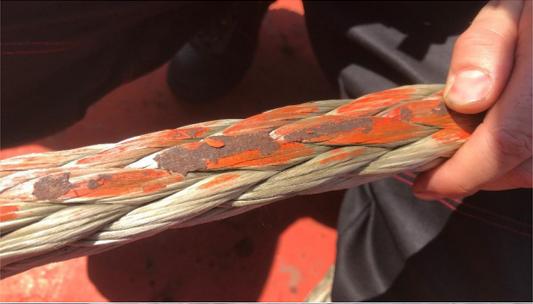
<p>Rope and deck/floor dirty and hardware paint dried on the rope. Recommended to inspect regularly for internal and external abrasion.</p>

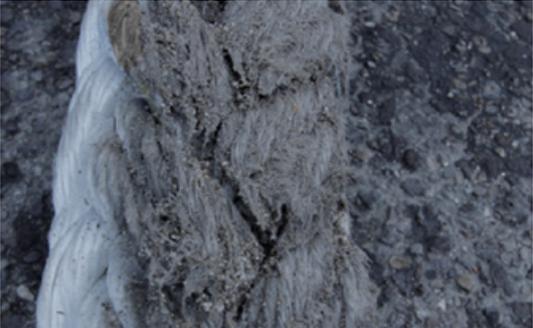
<p>Dirt in the rope structure, broken fibers. Internal and external abrasion. Rope must be retired.</p>
