Mooring Ropes Retirement Guidelines – Timm Acera Amundsen

1. Introduction

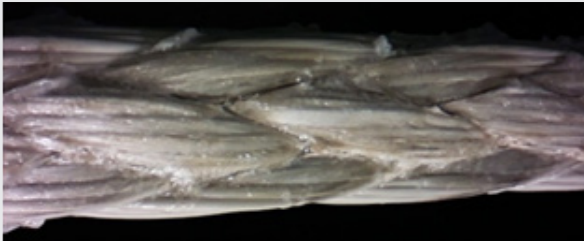
Fibers intact, no visible external damage.

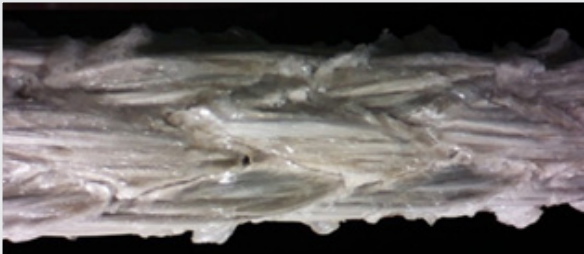
Visible abrasion localized where rope has been in contact with uneven surface. Recommend monitoring the rope, inspect and if needed repair the hardware and protect the rope.

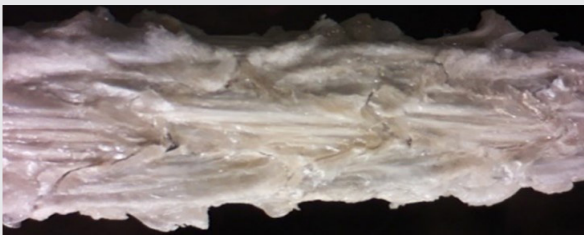
Abrasion clearly visible on more than 10% of the cross section of the rope. Rope must be retired.

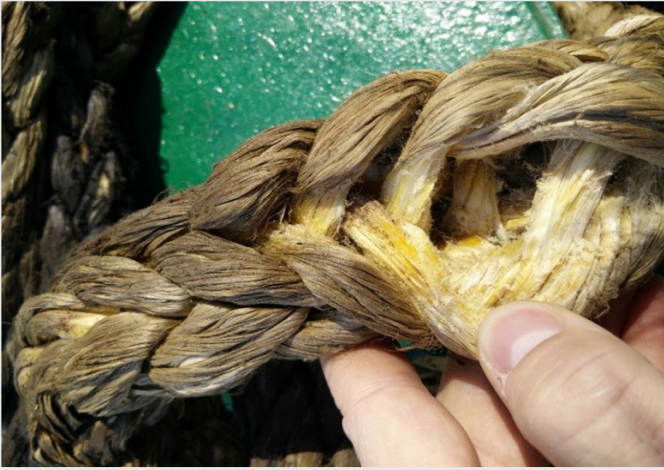
Minor visible internal abrasion. Some broken filaments. Recommend monitoring and inspecting the rope.

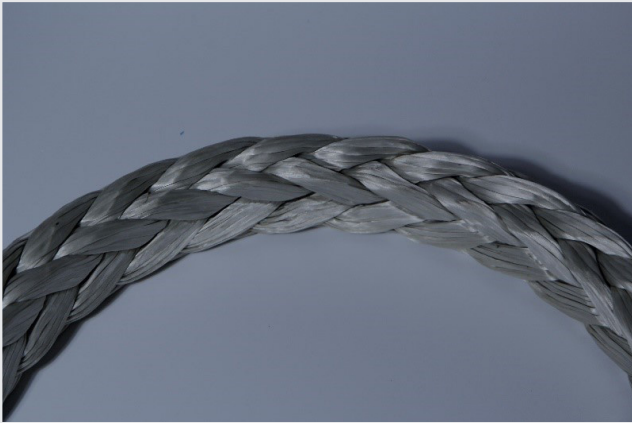
Fibers intact, no visible external damage.

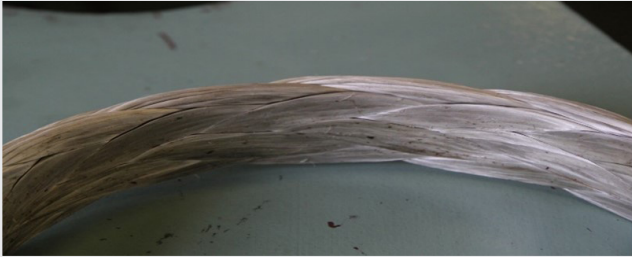
Glazed appearance, it is possible to recover the original shape of the rope by flexible bending and further use under tension. Monitor and inspect the rope regularly, investigate the root cause and do corrective actions. Recommend protecting the rope.

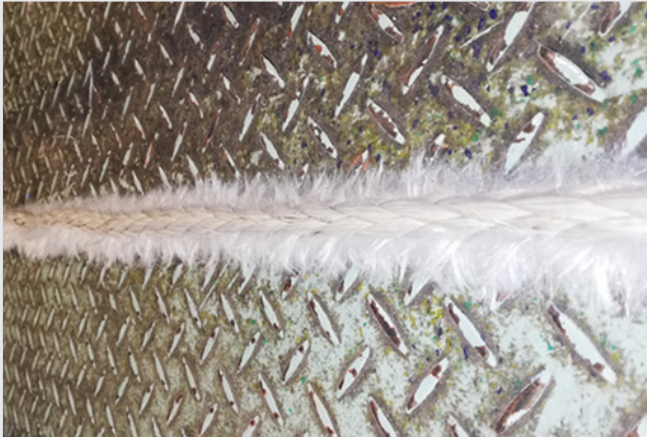
UV degradation on rope after tension is applied. Damaged fibers easily visible. The signs of UV degradation are not always visible before tension is applied. Attention must be paid to ropes that have been exposed to sunlight over an extensive period of time. Rope must be retired.

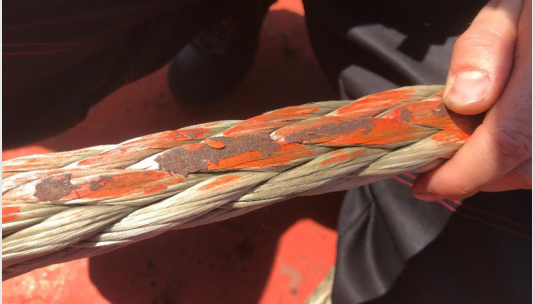
Yellow	Rope and deck/floor dirty and hardware paint dried on the rope. Recommended to inspect regularly for internal and external abrasion.

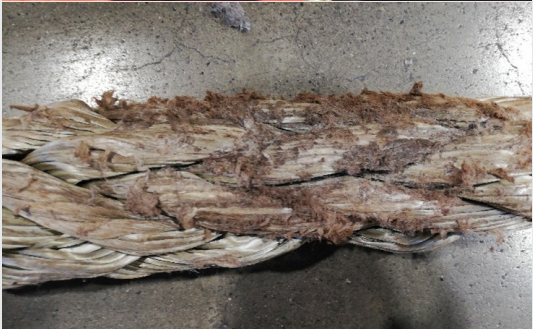
Red	Dirt in the rope structure, broken fibers. Internal and external abrasion. Rope must be retired.
