# Mooring Ropes Retirement Guidelines – Timm Acera daGama

### **3. Rope condition evaluation**

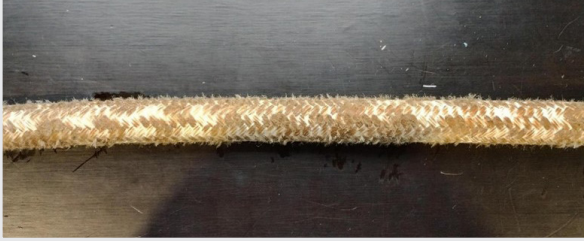
Cover is intact, no visible damages.

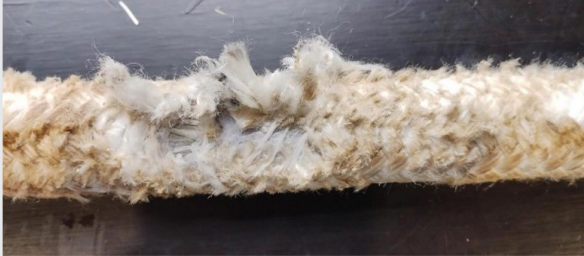
Visible damages to the cover, but the core is still intact without damages.  Recommend using Timm Repair Kit to fix damages as soon as possible to prevent further damages to cover and core.

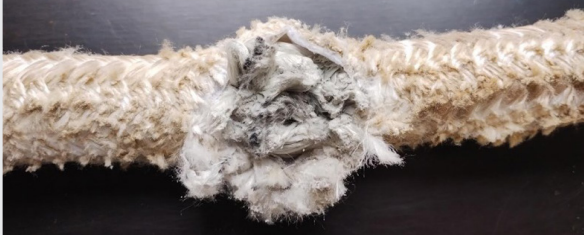
Visible damages to the cover and the core. Rope must be retired

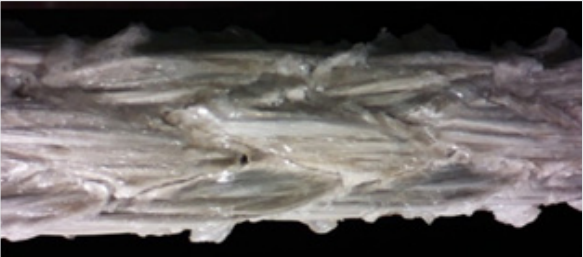
Visible abrasion localized where rope has been in contact with uneven surface. Recommend monitoring the rope, inspect and if needed repair the hardware and protect the rope.

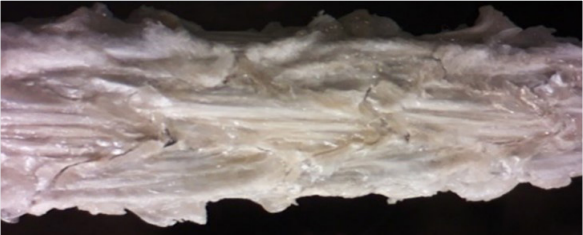
Abrasion clearly visible on more than 10% of the cross section of the rope. Rope must be retired.

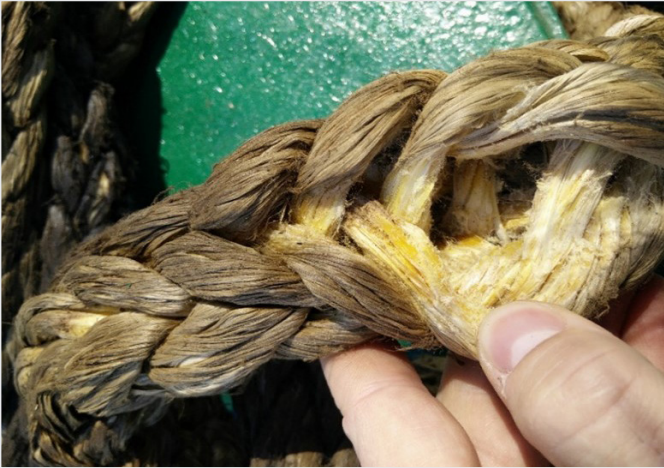
Minor visible internal abrasion. Some broken filaments. Recommend monitoring and inspecting the rope.

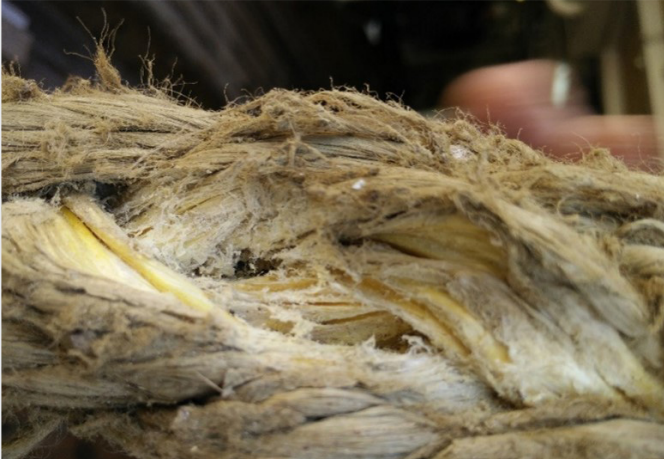
Internal abrasion clearly visible. Broken and powdered filaments in the center of the rope. Rope must be retired.

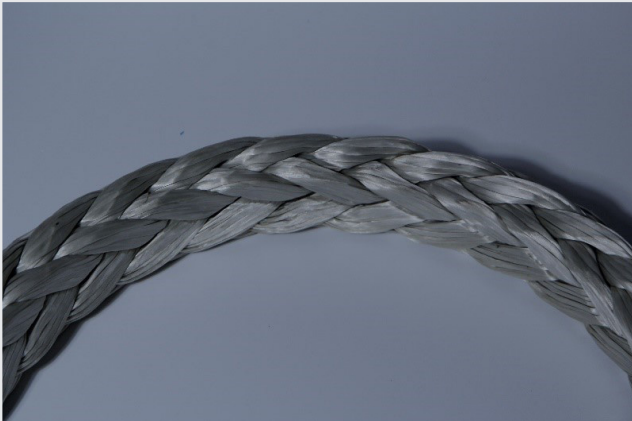
Fibers intact, no visible external damage.

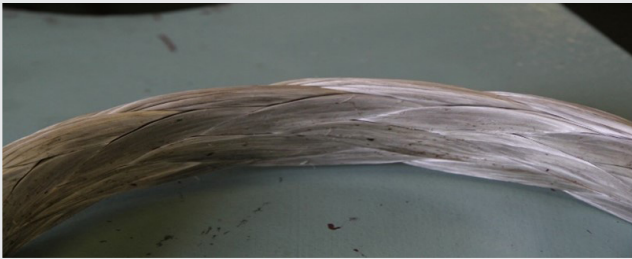
Glazed appearance, it is possible to recover the original shape of the rope by flexible bending and further use under tension. Monitor and inspect the rope regularly, investigate the root cause and do corrective actions. Recommend protecting the rope.

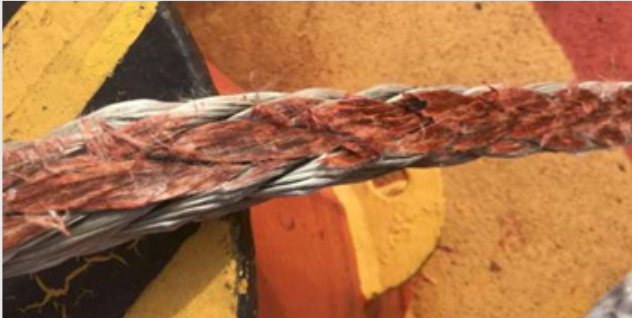
Glazed appearance due to heat build-up and melted fibers. Fibers damaged and non-recoverable flattening. Rope must be retired.

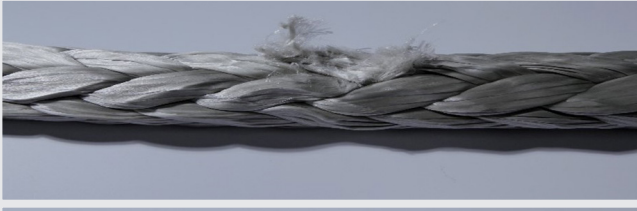
Yellow	Visible cut in fibers. Less than 3% of total amount of yarns. Recommend monitoring the rope, inspect and find sharp edge in the path of the rope causing the cut and repair. Protect the rope.

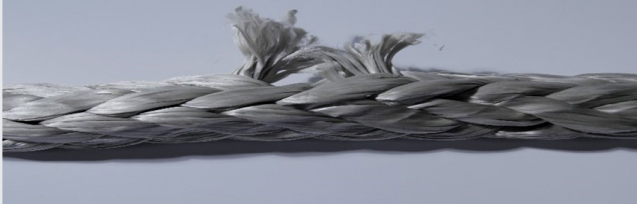
Red	Cut yarns clearly visible on more than 3% of total amount of yarns in whole rope. Rope must be retired. Inspect and find sharp edge in the path of the rope causing the cut and repair. Protect the new rope.

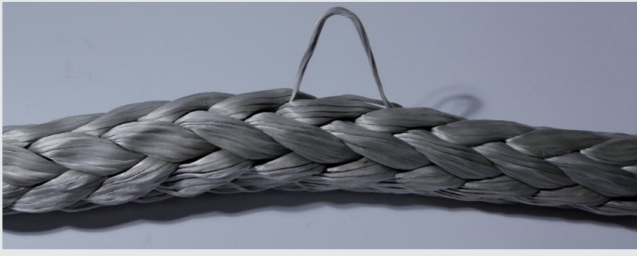
Yellow	Minor damage. Hide the fibers inside the rope. Inspect and find the obstacle causing the pulled yarns and remove or repair.

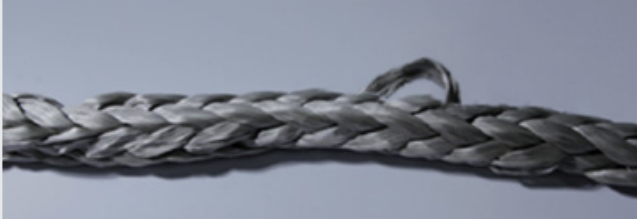
Yellow	Pulled strand can be repaired by working the strand into the rope by locating the damage on the length of the rope and by pulling and settling the strand. Inspect and find the obstacle causing the pulled strand and remove or repair.

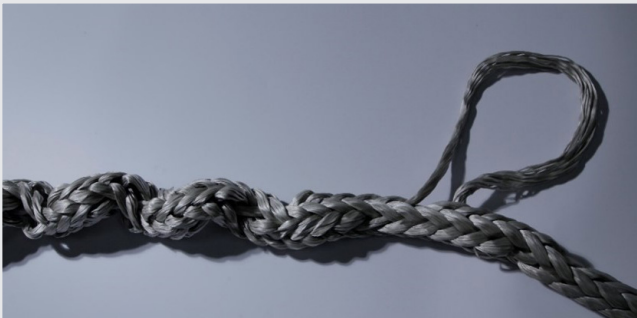
Red	Pulled strand caused major constructional damage on rope's length. Ropes must be retired. Inspect and find the obstacle causing the pulled strand and remove or repair.

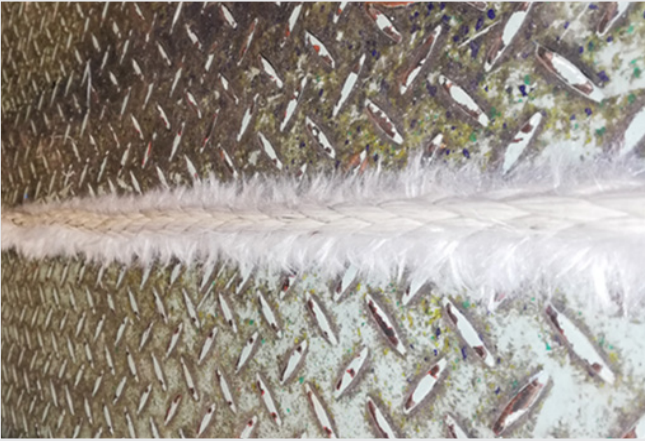
UV degradation on rope after tension is applied. Damaged fibers easily visible. The signs of UV degradation are not always visible before tension is applied. Attention must be paid to ropes that have been exposed to sunlight over an extensive period of time. Rope must be retired.

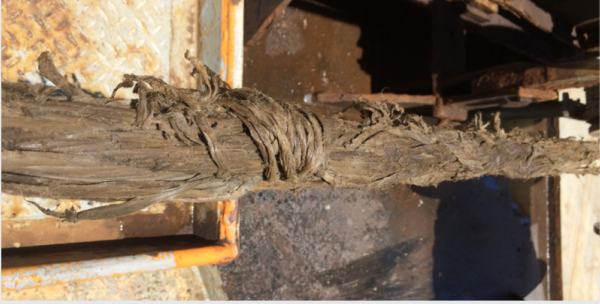
Rope log shows that there has been significant exposure to chemicals. Rope must be retired.

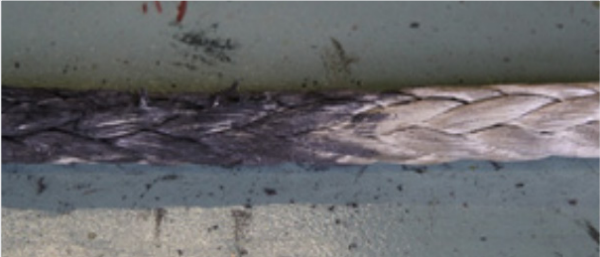
Rope discoloration, brittle fibers, fusion, bonding of fibers, hardness. Chemical exposure suspected. Rope must be retired.

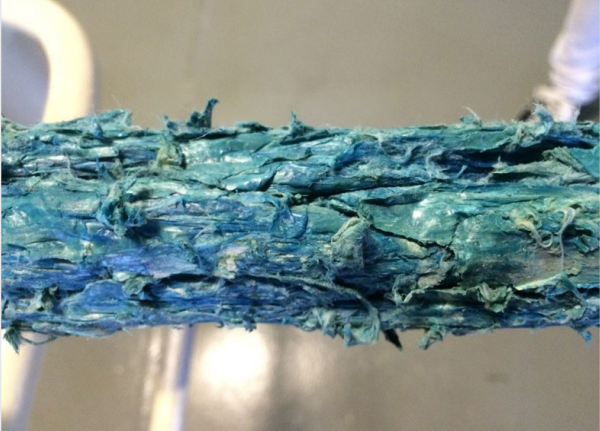
Known significant exposure to high temperature. Melted and/or discoloration.

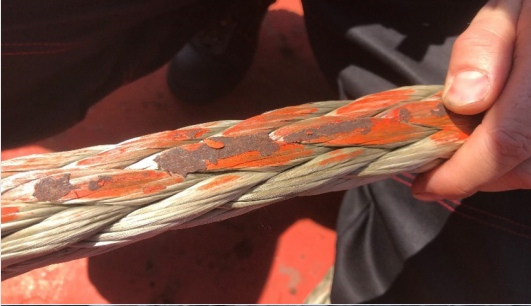
Rope and deck/floor dirty and hardware paint dried on the rope. Recommended to inspect regularly for internal and external abrasion.

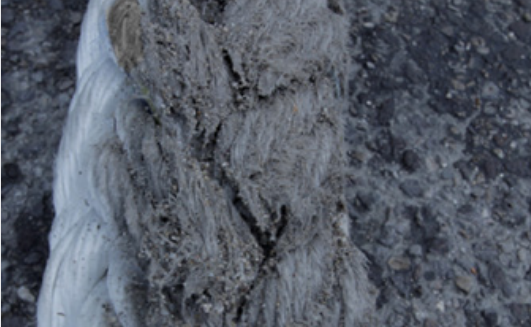
Dirt in the rope structure, broken fibers. Internal and external abrasion. Rope must be retired.
