Mooring Ropes Inspection & Retirement Guidelines – Timm Acera Amundsen

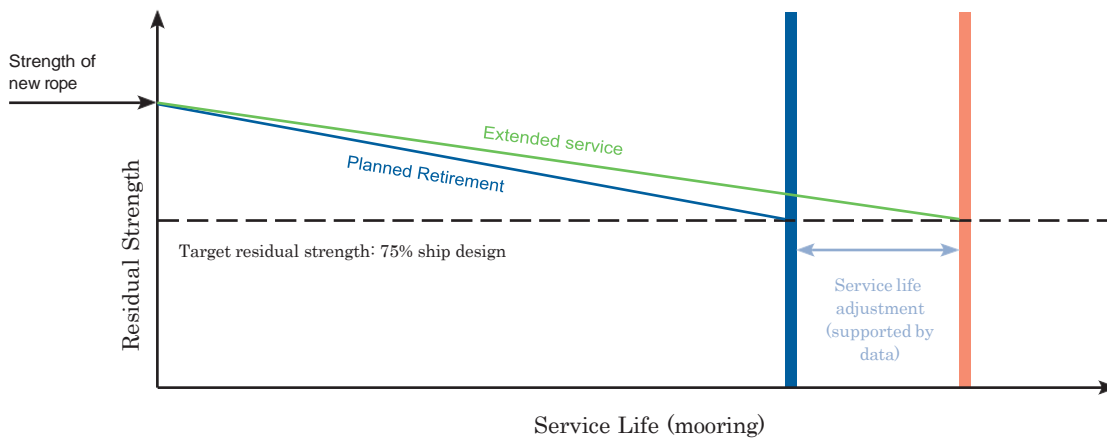
Service life adjustment according to OCIMF MEG4

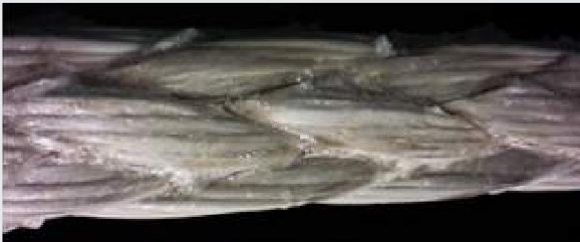
Fibers intact, no visible external damage.

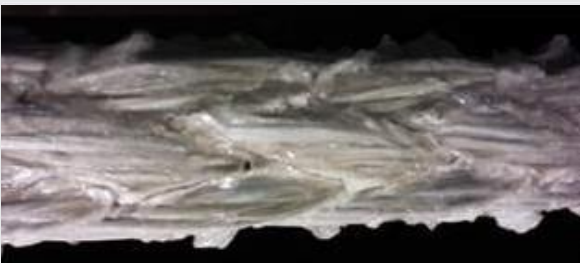
Visible abrasion localized where rope has been in contact with uneven surface. Recommend monitoring the rope, inspect and if needed repair the hardware and protect the rope.

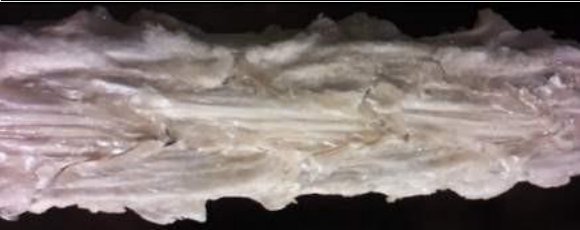
Abrasion clearly visible on more than 10% of the cross section of the rope. Rope must be retired.

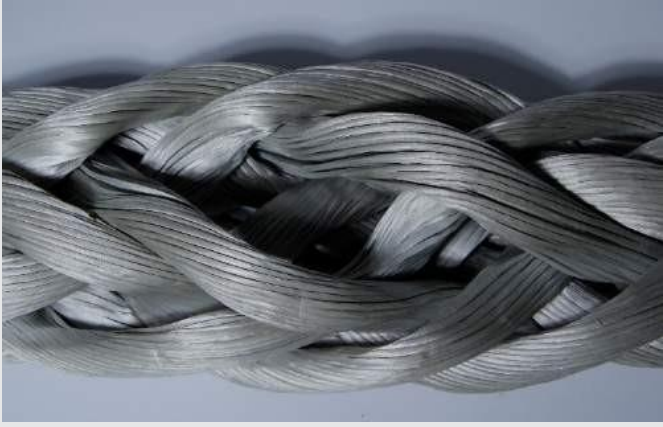
Green	Fibers intact, no visible external damage.

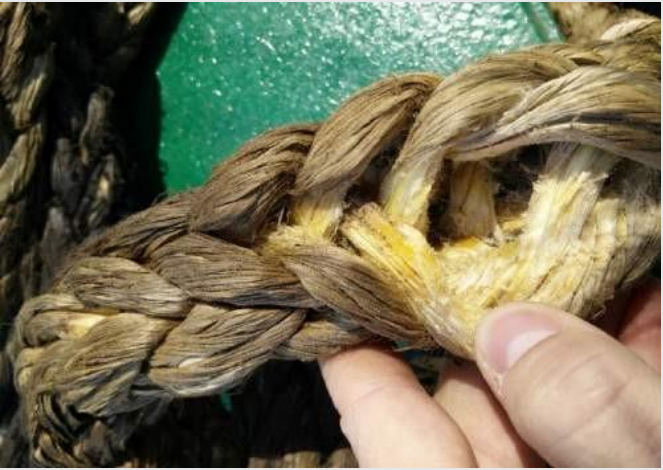
Yellow	Minor visible internal abrasion. Some broken filaments. Recommend monitoring and inspecting the rope.

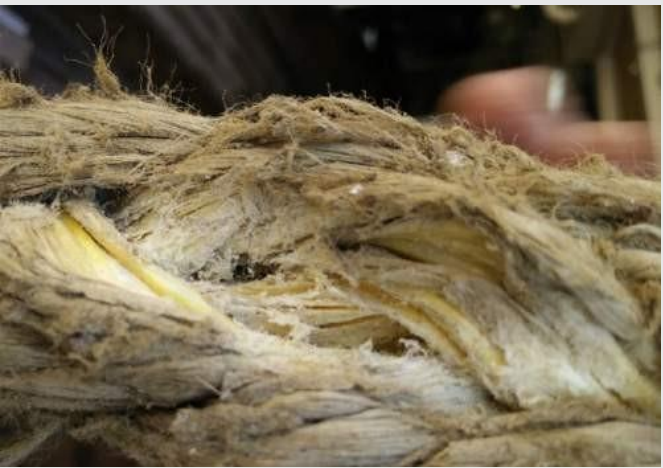
Red	Internal abrasion clearly visible. Broken and powdered filaments in the center of the rope. Rope must be retired.

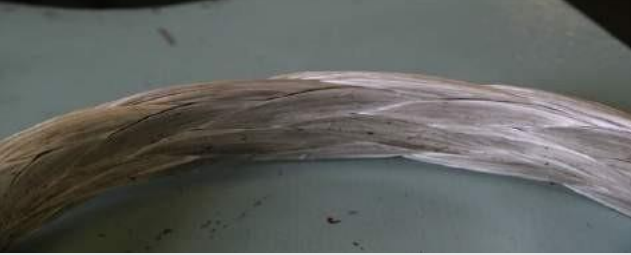
<p>Glazed appearance, it is possible to recover the original shape of the rope by flexible bending and further use under tension. Monitor and inspect the rope regularly, investigate the root cause and do corrective actions. Recommend protecting the rope.</p>

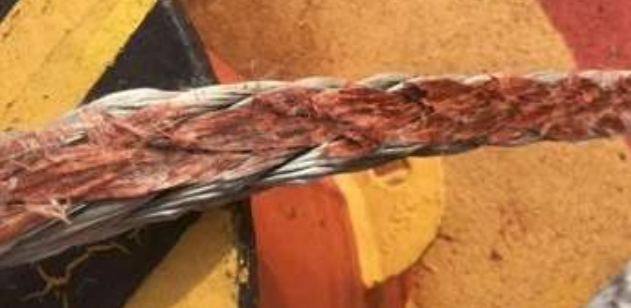
<p>Glazed appearance due to heat build-up and melted fibers. Fibers damaged and non-recoverable flattening. Rope must be retired.</p>

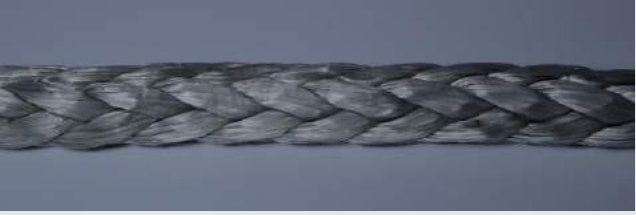
Fibers intact, no visible external damage.

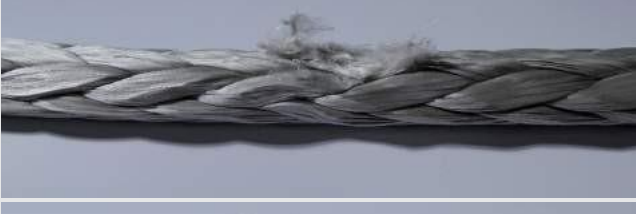
Visible cut in fibers. Less than 3% of total amount of yarns. Recommend monitoring the rope, inspect and find sharp edge in the path of the rope causing the cut and repair. Protect the rope.

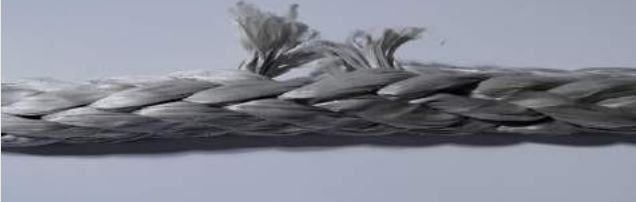
Cut yarns clearly visible on more than 3% of total amount of yarns in whole rope. Rope must be retired. Inspect and find sharp edge in the path of the rope causing the cut and repair. Protect the new rope.

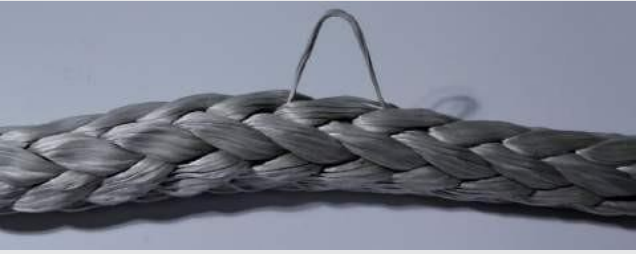
Fibers intact, no visible external damage.

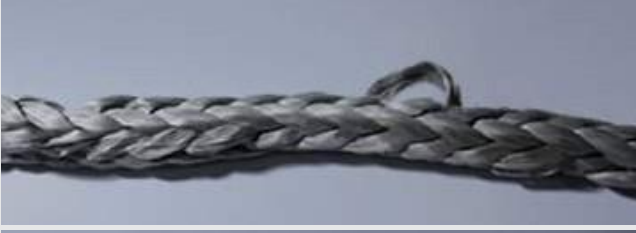
Pulled strand can be repaired by working the strand into the rope by locating the damage on the length of the rope and by pulling and settling the strand. Inspect and find the obstacle causing the pulled strand and remove or repair.

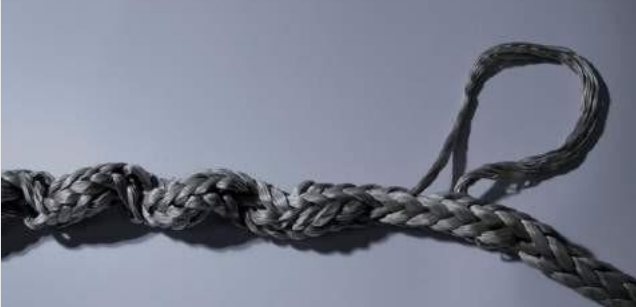
Pulled strand caused major constructional damage on rope's length. Ropes must be retired. Inspect and find the obstacle causing the pulled strand and remove or repair.

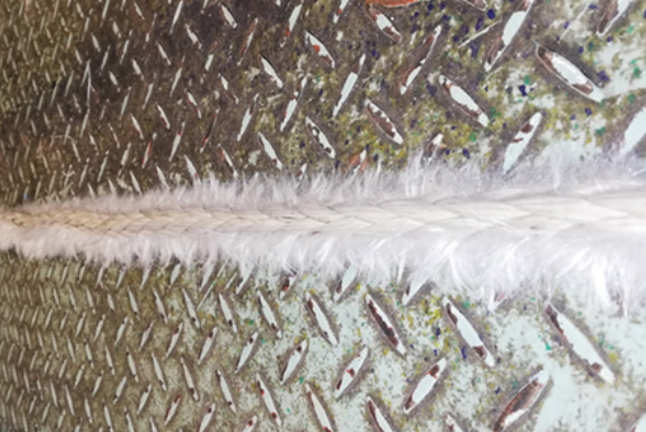
UV degradation on rope after tension is applied. Damaged fibers easily visible. The signs of UV degradation are not always visible before tension is applied. Attention must be paid to ropes that have been exposed to sunlight over an extensive period of time. Rope must be retired.

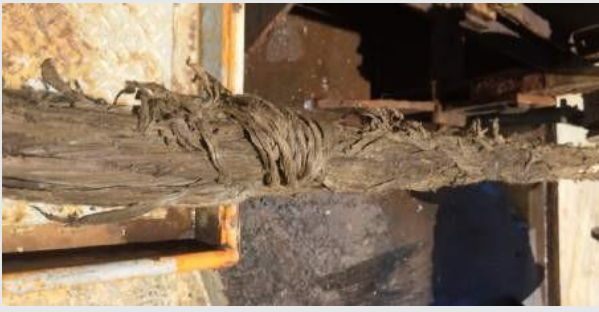
<p>Rope log shows that there has been significant exposure to chemicals. Rope must be retired.</p>

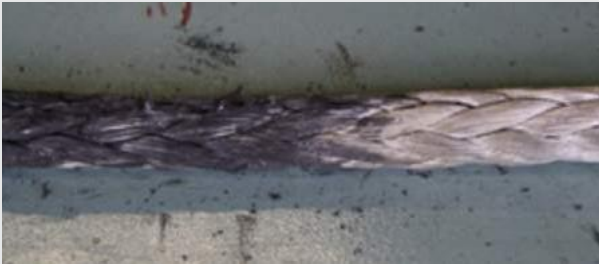
<p>Rope discoloration, brittle fibers, fusion, bonding of fibers, hardness. Chemical exposure suspected. Rope must be retired.</p>

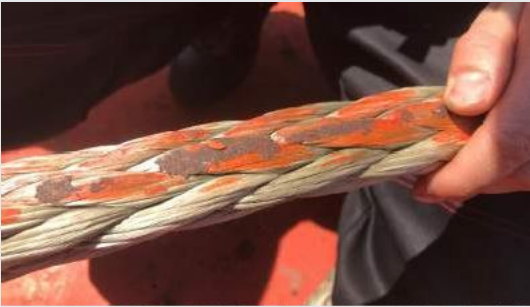
Yellow	Rope and deck/floor dirty and hardware paint dried on the rope. Recommended to inspect regularly for internal and external abrasion.

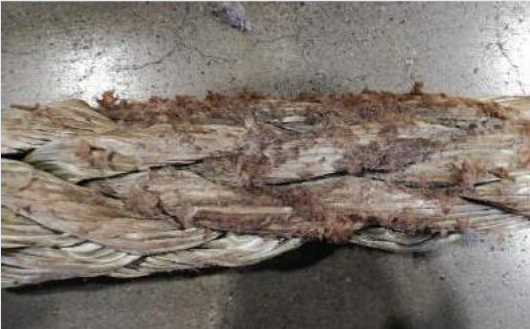
Red	Dirt in the rope structure, broken fibers. Internal and external abrasion. Rope must be retired.
