Timm Master 12 SBA™ Tail

Use and Care Guidelines for Mooring Tails

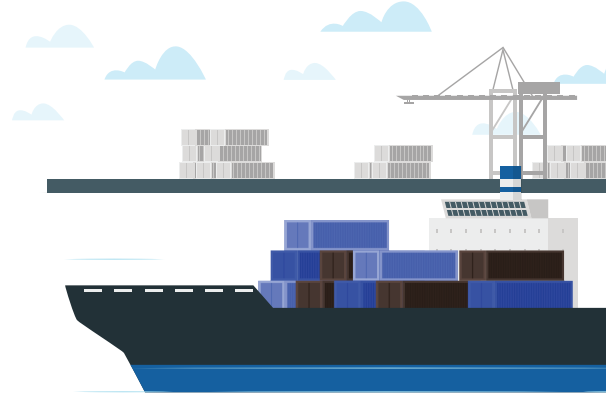
Timm™ Master 12 SBA™ Tail is a premium mixed polymer tail with polyester protected eyes in each end. The fiber consists of Timm B5 polyolefin yarns and high tenacity polyester in the outer layer, giving the rope very good abrasion properties and excellent UV resistance, in addition to being buoyant.

Colour:	White and blue (anti-twist indicator)
Construction:	12x1 strand braided
Floating:	Yes
Elongation:	12-13% at break (stabilized) 18% at break (new)
Melting Point:	165°C
Water Absorption:	<0.1%
Designed Lifetime:	2000 mooring hours

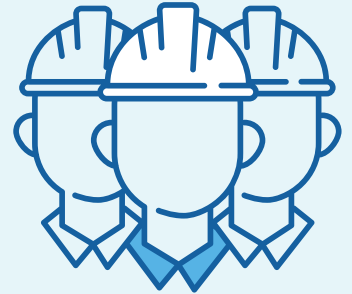
2 This rope is equipped with SBA™

Timm Snap Back Arrestor (SBA™) was developed and brought to market by Timm in 2019. The Snap Back Arrestor is a highly effective safety feature designed to reduce the snap back effect of a rope, but it is important to note that it should never be relied upon as the sole safety measure. All safety measures related to mooring must be followed at all times when using SBA™ ropes.

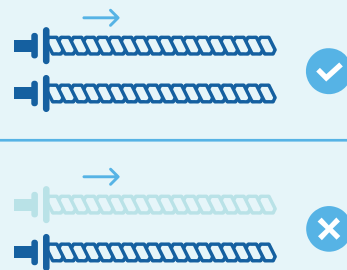
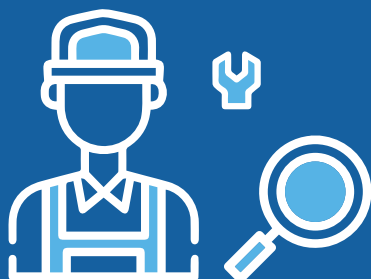
Ropes working in parallel must be of the same model, construction, material, running time and condition (used/new) to prevent one of the two ropes from bearing most of the load. Ropes from different manufacturers may have slightly different elongations.

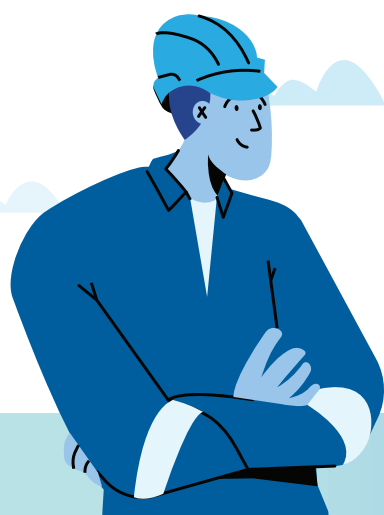
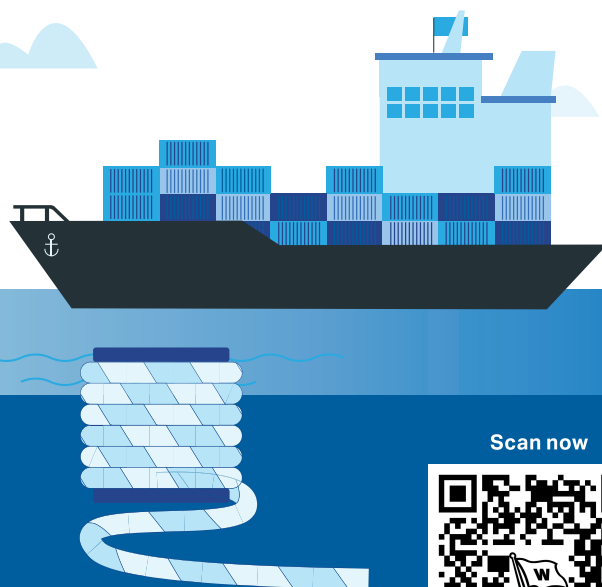
Working Load Limits: 50% of ship design MBL
Mximum Recommended Working Load: 22% of ship design MBL
